AFWAL-TR-81-2094

A RETIREMENT-FOR-CAUSE SUTDY OF AN ENGINE TURBINE DISK

November 1981

Aero Propulsion Laboratory
Air Force Wright Aeronautical Laboratories
Air Force Systems Command
Wright-Patterson Air Force Base, Ohio 45433

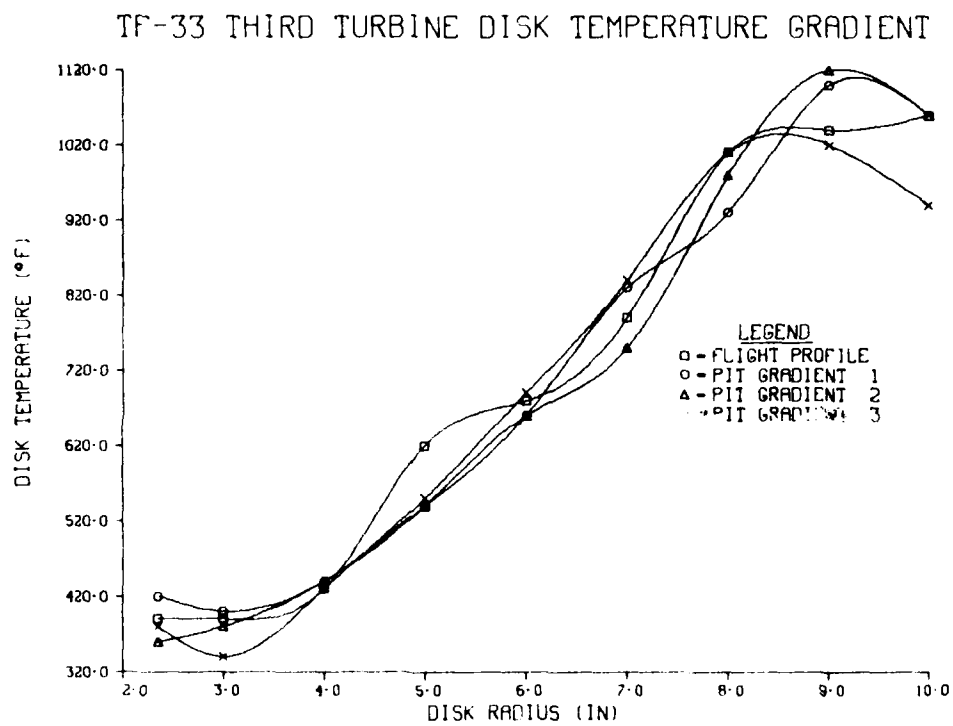
Figure 8
TF33 Third Turbine Disk Temperature

Through an iterative method it was calculated that the spin pit test should be run from 0 to 6400 RPM with the thermal gradient that is labeled "Flight Profile" in Figure 8. However, this desired thermal gradient could not be achieved in the pit and, in fact, the actual test gradient had to be modified three times (shown in Figure 8 as gradient 1, 2, and 3) to reduce the spin pit cycle time. In addition, the 0 RPM engine shutdown condition could not be achieved in the pit and had to be changed to 500 RPM. All three combined stress (thermal and centrifugal) gradients for the run-up and run-down side of the three pit cycles are shown in Figure 4 for the nominal stress and in Figure 9 for the peak stress. The values from these two sets of curves are the values used in the fracture analysis.

As was discussed, three different thermal gradients were used during the duration of the fracture testing. The amount of testing done under each of the three gradients was as follows: Gradient #1, Cycle 1 to Cycle 597; Gradient #2, Cycle 598 to Cycle 1500; Gradient #3, Cycle 1501 to test completion. These three gradients stress/crack propagation effects were considered in the fracture analysis assuming linear cumulative damage.

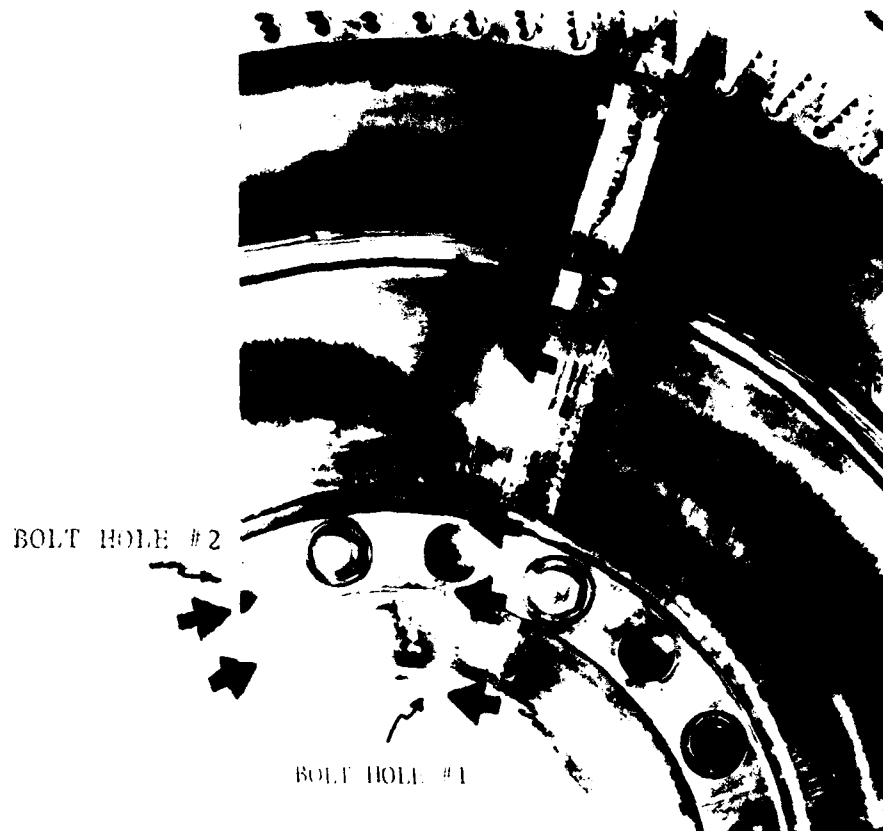
Figure 14
Bolt Hole Cracks at Test Completion

Testing was ended at the 13,860 cycle point after the disk could no longer be spun within acceptable balance limits. Figure 14 shows the disk after test completion.
